Manhole Inspection Summary

Manhole # S02EE2019MH

Insp Date: **8/9/06 9:15 AM**

Location Address: **6605 WESTERN RUN DR**

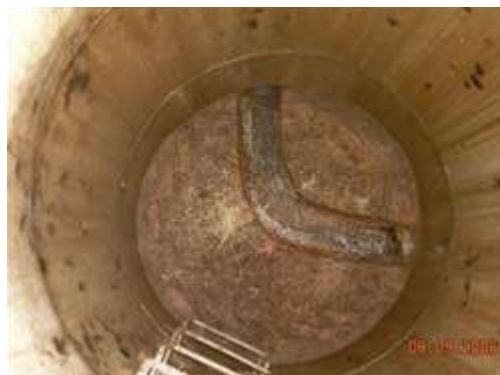
Top View

Corbel infiltration. Evidence of surcharge - Bench debris. Channel debris.

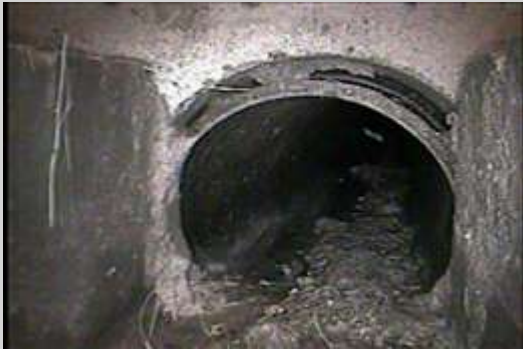
8 in. Circular Gravity Sewer Pipe Out @ 12 O'Clock

Comments **The O12 pipe seal is not flush to the pipe.**

Deposits: ☐ None ☒ **Mud** ☐ Sludge ☒ **Debris** ☐ Grease

Silt Depth: **0.5** (in.) Deposits Extent: **Light**

Infiltration: **Evidence** Pipe Seal Cond: **Unknown**

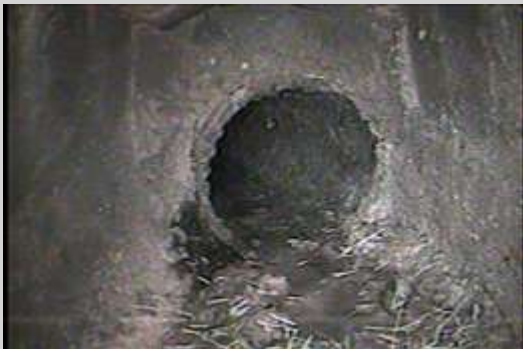
6 in. Circular Gravity Sewer Pipe In @ 3 O'Clock

Channel root intrusion.

Deposits: ☐ None ☒ **Mud** ☐ Sludge ☒ **Debris** ☒ **Grease**

Infiltration: **Evidence** Pipe Seal Cond: **Unknown**
